Manhole Inspection Summary

Manhole # S53M__022MH

Insp Date: **3/4/09 10:50 AM**

Location Address: **1008 DECKER-POTOMAC-ALLEY**

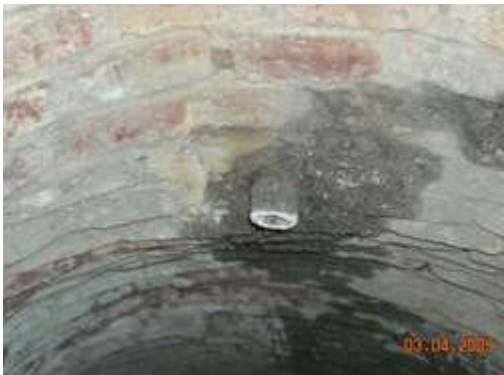
Defect 5

PIPE INTRUSION @ 6 OCLOCK
CORBEL WALL

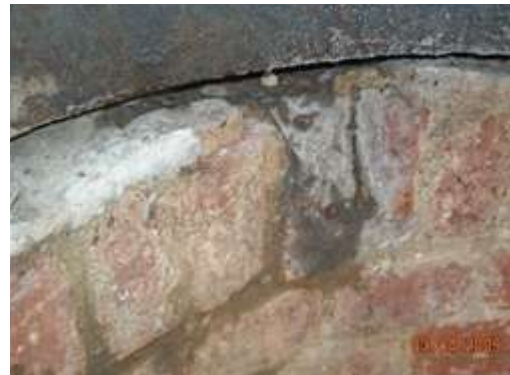
Defect 4

Infiltration: ☐ None ☒ **Joint** ☐ Cracks ☐ Mortar ☐ Roots ☐ Wall

INFILTRATION @ CHIMNEY/FRAME
JOINT

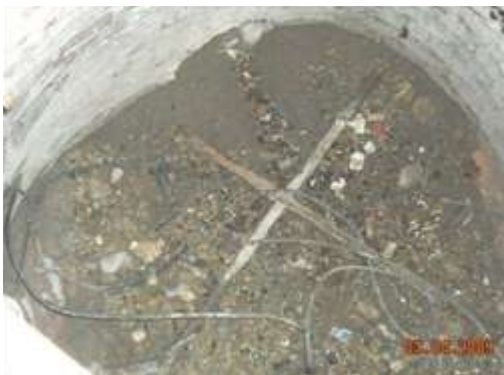
Defect 3

Condition: ☐ Sound ☐ Cracked ☐ Root Intrusion ☐ Deteriorated ☐ Leaks ☒ **Debris**

DEBRIS IN TERMINAL CHANNEL

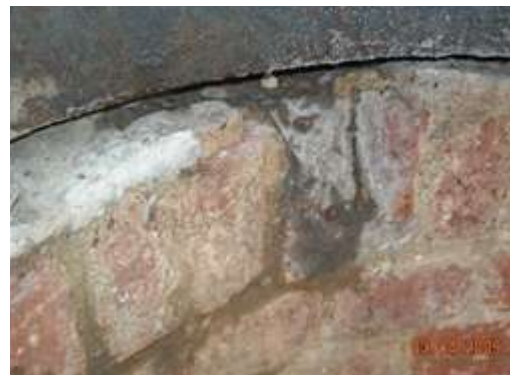
Defect 2

Condition: ☐ Sound ☐ Cracked ☐ Root Intrusion ☐ Loose Brick ☒ **Deteriorated**

DETERIORATED CHIMNEY BRICK

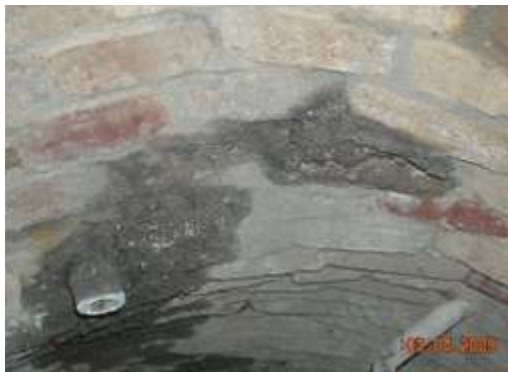
Defect 1

Infiltration: ☐ None ☐ Joint ☐ Cracks ☐ Mortar ☐ Roots ☒ **Wall**

INFILTRATION @ CORBEL WALL

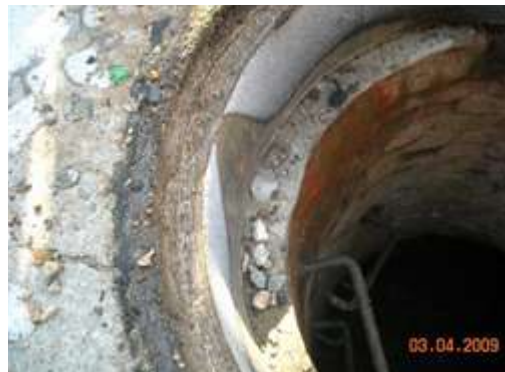
Offset: **2** (in.)

FRAME OFFSET

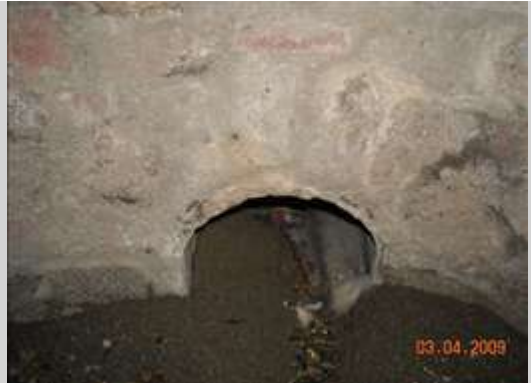
12 O'Clock Outflow

8 in. Circular Gravity Sewer
Pipe Out @ 12 O'Clock

Deposits: ☐ None ☒ **Mud** ☐ Sludge ☐ Debris ☐ Grease

Silt Depth: **1** (in.) Deposits Extent: **Light**
